# Introduction to footpath routes

# Foot Path Map Caldera Lake Toyako/Utsu Volcano

Yosomi-yama Route: craters and crypto-dome from the 1910 eruption and the recovering woods  
Kompira-yama Route: craters from the 2000 eruption, crypto-dome and hazard memorials

Supervising editors: Hiromu Okada, Tadahide Ujii  
Edited by: Civil Engineering Research Institute for Cold Region, Incorporated Administrative Agency Public Works Research Institute  
Published by: Toya Caldera and Utsu Volcano Global Geopark Council  
Cooperating organizations: Hokkaido Regional Development Bureau, Ministry of the Environment, Forestry Agency, Hokkaido Government, Toyako Town, Sobetsu Town, Hokkaido Tourism Organization, Toya Guide Center, Crisis & Environment Management Policy Institute, Asia Air Survey Co., Ltd., Shin Engineering Consultants Co., Ltd.

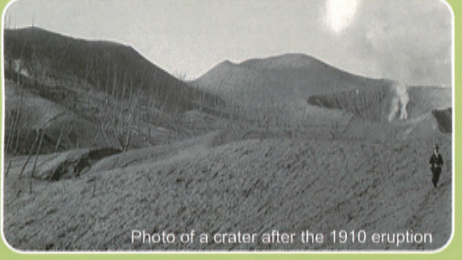
#### 1 Observation Point 1: Craters formed by the 1910 eruption

Photo of a crater after the 1910 eruption

The 1910 eruption caused 45 craters to form. A century later, they are now covered with forests.

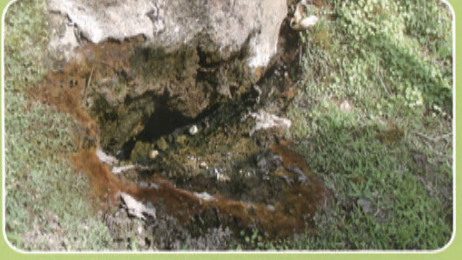
#### 2 Observation Point 2: Fumarole

A remaining steam vent on the uplifted fault scarp of Yosomi-yama. The steam temperature is currently around 50°C.

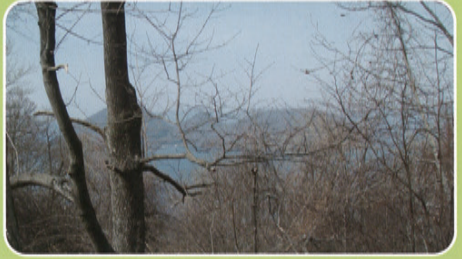
#### 3 Observation Point 3: Observatory at the top of Yosomi-yama

Panoramic view of Caldera Lake Toyako, and the recovering forests of Yosomi-yama. Around 110,000 years ago, a gigantic caldera-forming eruption created Caldera Lake Toyako, and the Nakajima (central islands) dome complex emerged around 50,000 years ago.

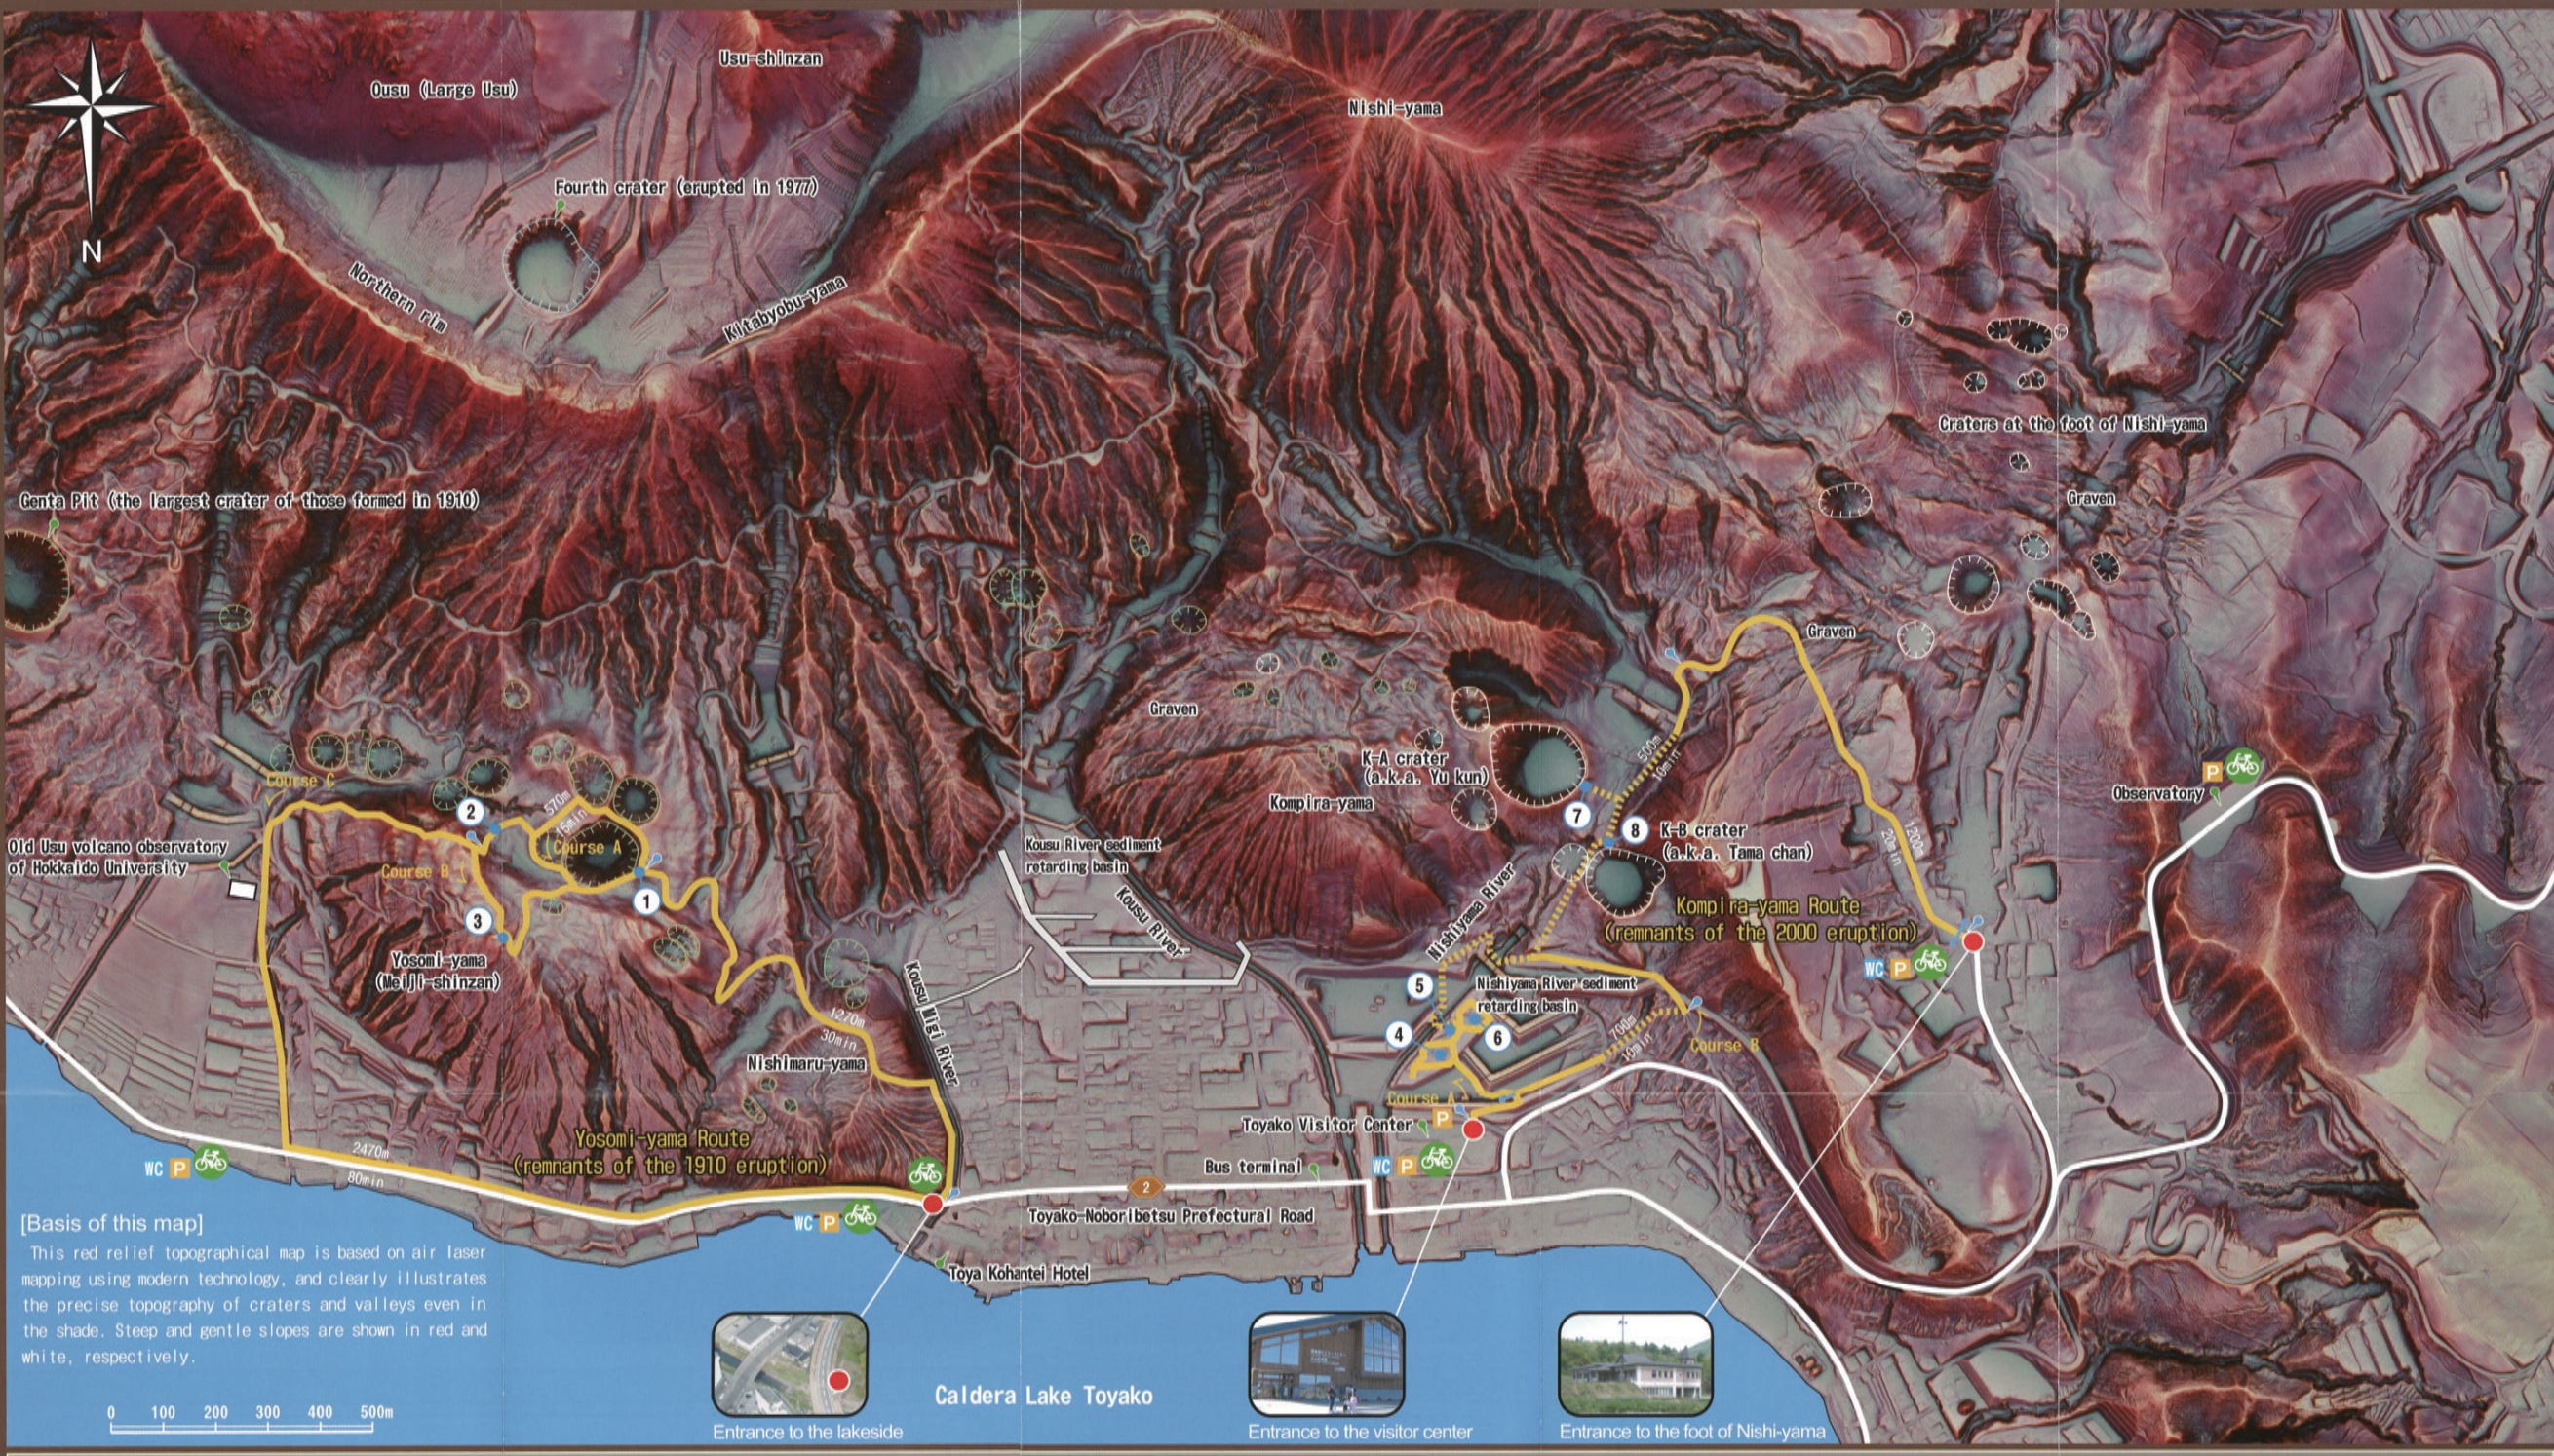
[Basis of this map]  
This red relief topographical map is based on air laser mapping using modern technology, and clearly illustrates the precise topography of craters and valleys even in the shade. Steep and gentle slopes are shown in red and white, respectively.

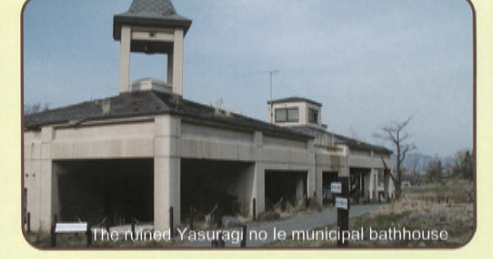
#### 4 Observation Point 4: The ruined municipal bathhouse (Yasuragi no Ie)

Yasuragi no Ie municipal bathhouse ruined by flowing hot mudflow

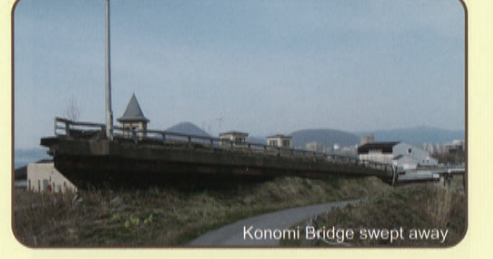
#### 5 Observation Point 5: Konomi Bridge

Hot mudflow swept Konomi Bridge (which used to span National Route 230) a distance of 100 m from its original location.

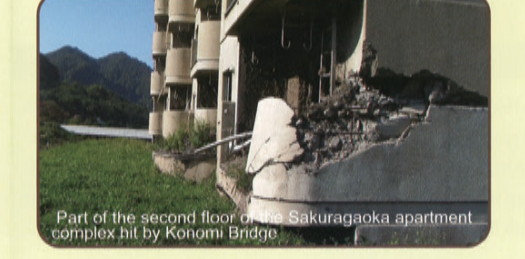
#### 6 Observation Point 6: Sakuragaoka apartment complex

The first floor of the Sakuragaoka apartment complex was buried in gushing hot mudflow from the eruption in 2000, and the second floor was scarred by Konomi Bridge as the photo shows.

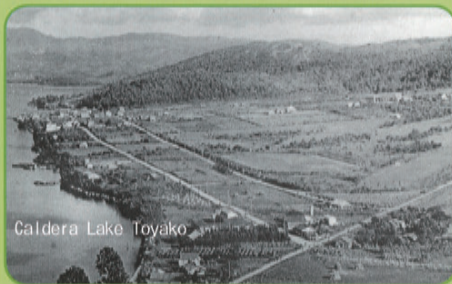
1931

This photo shows that the alluvial fan on the north side of Utsu Volcano where Toyako Onsen is located, has developed since the early Showa era. Around 1940, this area hosted a golf course, farming fields and a municipal athletics field. Houses were also constructed, roads expanded and railways put into service.

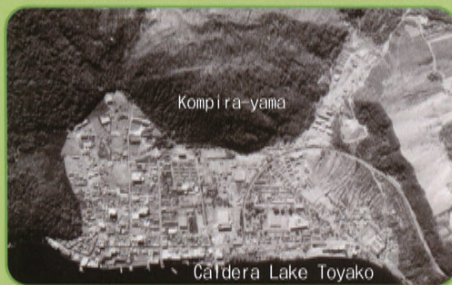
1977 (before the eruption)

This aerial photo from before the 1977-1978 eruption shows how Toyako Hot Spring Resort sprawled around the alluvial fan, and that there were no rivers.

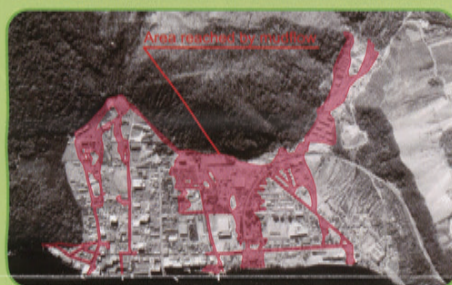
1978

Although the 1977-1978 eruption itself caused no casualties, three people were killed by mudflow triggered by rainfall on October 24, 1978.

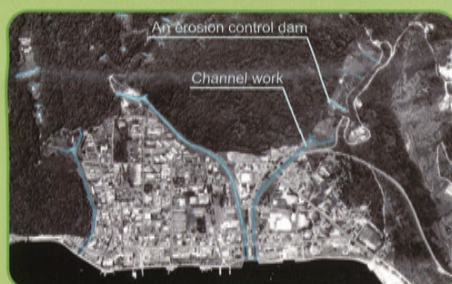
1995

After the 1977-1978 eruption, erosion control facilities were constructed to protect Toyako Hot Spring Resort from mudflow and debris flow. These included an erosion control dam to mitigate mudflow on the upstream side of the resort area and channel work to safely discharge mudflow and floods.

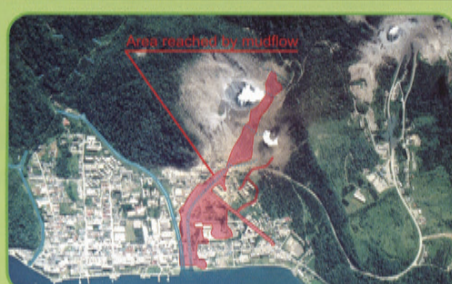
The 2000 eruption created an eruptive crater near Toyako Hot Spring Resort from which hot mudflow discharged. Although mudflow in the early days was controlled by the erosion control facilities, the large amount of mudflow in 2000 caused damage to the resort area.

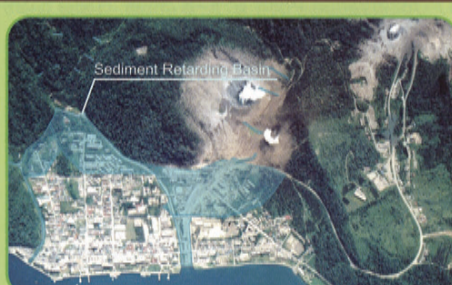
2000 (after the eruption)

After the damage, a large-scale sediment retarding area was built to protect Toyako Hot Spring Resort against sediment disasters. Apartment complexes and other buildings shown in blue on the map to the left were moved, and facilities to control sediment were built there.

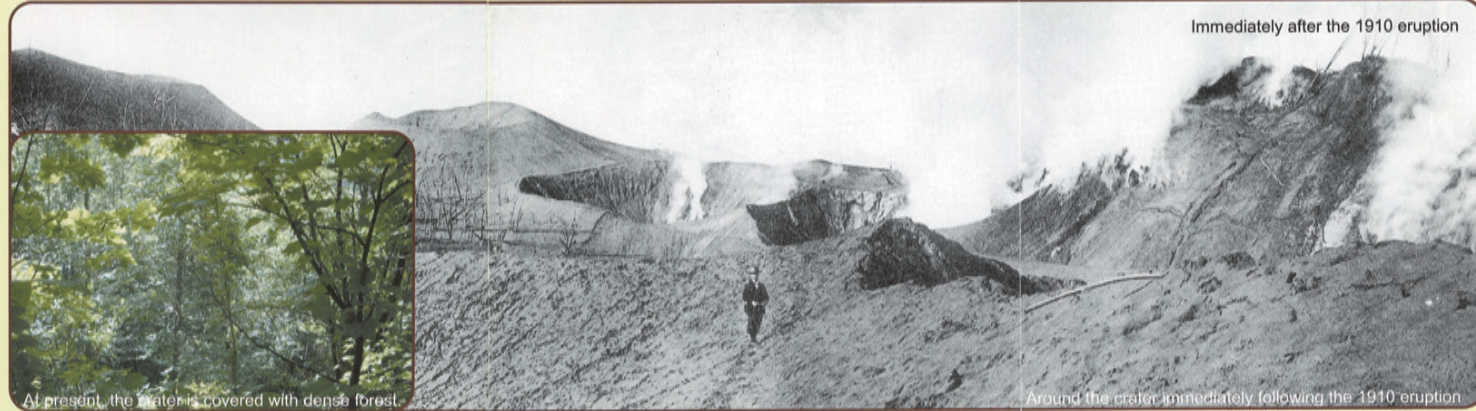
The 1910 eruption

At present, the crater is covered with dense forest. Immediately after the 1910 eruption. Around the crater immediately following the 1910 eruption. Photographed by Fusakichi Omori

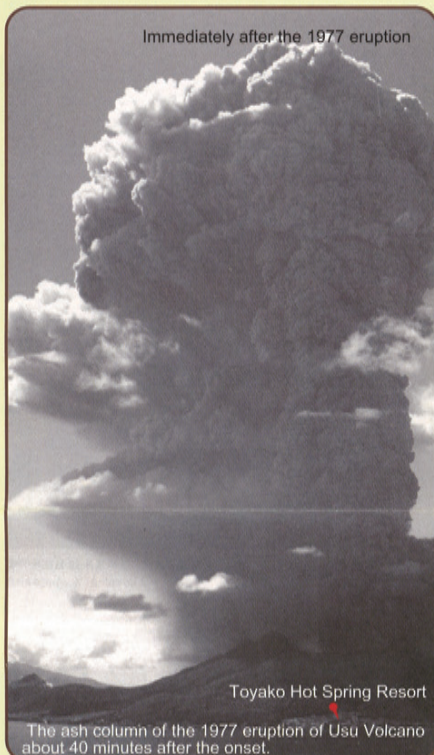
The 1977-1978 eruption

The ash column of the 1977 eruption of Utsu Volcano about 40 minutes after the onset.

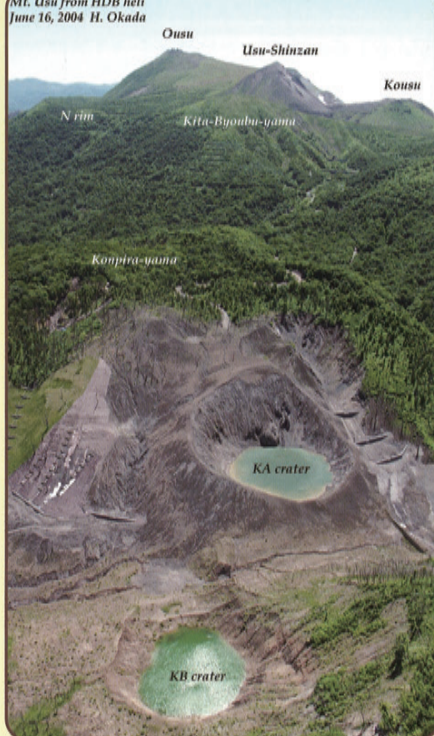
The 2000 eruption

An apartment building in the Konomi Valley was gradually destroyed by the active volcanic fault during the 1977-1982 activity of Utsu Volcano (right). This former residential area was transformed into an area of erosion control dams (left) that contributed to significantly reducing the damage from the 2000 eruption.

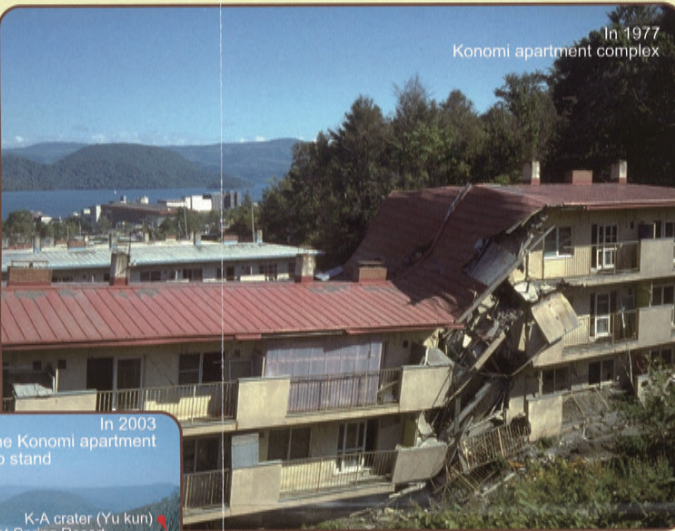
The photo on the left shows the site of the previous Konomi apartment complex after the 1977-1978 eruption. The lot was improved to create a disaster prevention area, which performed its function when the volcano erupted again in 2000.
